CITY OF CANFIELD

2018 CITY-WIDE ROADWAY ASSESSMENT

MAY 2018

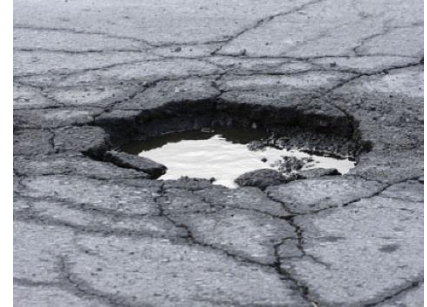
2.1 PATCHING/DEBONDING AND POTHOLES

Patching is performed by the City Public Works Department when potholes open up in the road. Potholes are caused when moisture penetrates the asphalt and is able to get down into the base material. The winter freeze-thaw cycle is when most potholes will surface throughout the City. The moisture will freeze, causing it to expand. When the moisture melts during a warmer cycle the road will then contract. This causes weakening of the asphalt, this combined with the wear and tear of traffic will open up the asphalt causing potholes. Typically, potholes are filled with either hot or cold mix. Hot mix is asphalt material, usually from an asphalt plant, that is installed in the pothole area. Usually the damaged material is removed and the hot mix is placed at a sufficient depth and compacted. This is usually a better long-term option. Typically, communities use cold mix material to patch roads. This is usually a short-term fix but is cheaper than the alternative hot mix.

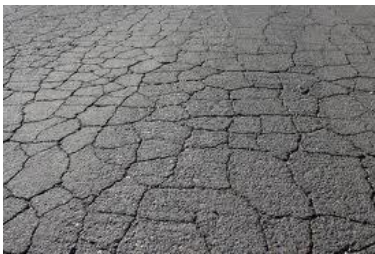
2.2 MAP CRACKING

Map cracking, also known as alligator cracking, is caused by fatigue of the asphalt surface due to the repeated loading of the traffic. Typically, the cracking begins at the base of the asphalt surface and works its way up to the surface. Map cracking starts as a series of parallel, longitudinal cracking on the surface and progresses into map cracking as the parallel cracks begin to connect. Map cracking can later turn into potholes due to the underlying base issues that initially cause the map cracking to occur.

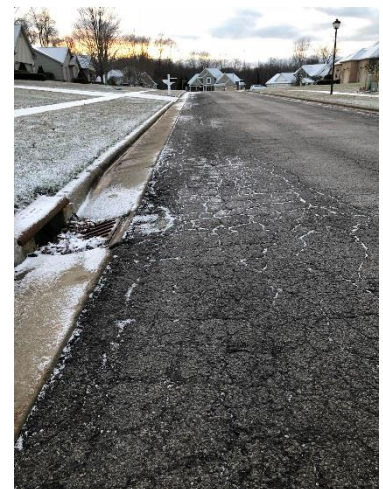
2.3 BASE FAILURE

Base failure occurs due to lateral movement in the pavements subgrade. A variety of issues could cause this including insufficient pavement thickness, inefficient asphalt compaction, or the infiltration of moisture. Typically, the repair for this is a full depth repair. The edge areas of White Oak Court have prevalent rutting and base failure which will require a full depth repair prior to resurfacing. For the purposes of this study, rutting was identified as a form of base failure.

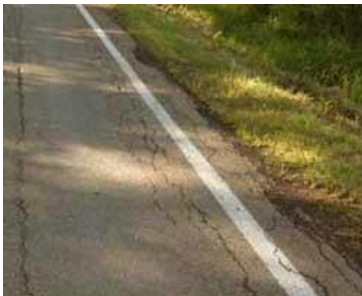
2.5 WHEEL TRACK AND EDGE CRACKING

Wheel track and edge cracking is cracking that occurs on the edge of the asphalt or within the typical wheel tracks. These types of cracks usually run parallel to the outer edge of the pavement and cracking is increased by continuous traffic loading. Edge cracking can be caused by weakened base or subgrade near the edge of the pavement. This type of cracking can lead to raveling, which means that the edge has broken off from the main asphalt road.
