# CITY OF CANFIELD

## 2021 PAVEMENT ASSESSMENT

**MAY 2021**

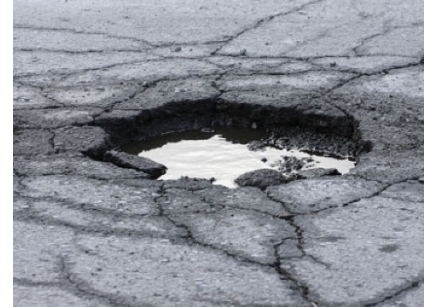
### 2.1 PATCHING/DEBONDING AND POTHOLES

Patching is performed by the Public Works Department when potholes open up in the road. Potholes are caused when moisture penetrates the asphalt and is able to get down into the base material. The winter freeze-thaw cycle is when most potholes will surface throughout the City. The moisture will freeze, causing it to expand. When the moisture melts during a warmer cycle the road will then contract. This causes weakening of the asphalt, this combined with the wear and tear of traffic will open up the asphalt causing potholes. Typically, potholes are filled with either hot or cold mix. Hot mix is asphalt material, usually from an asphalt plant, that is installed in the pothole area. Usually the damaged material is removed and the hot mix is placed at a sufficient depth and compacted. This is usually a better long-term option. Typically, communities use cold mix material to patch roads. This is usually a short-term fix but is cheaper than the alternative hot mix.

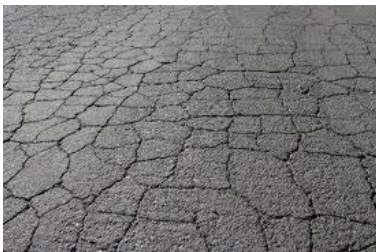
### 2.2 MAP CRACKING

Map cracking, also known as alligator cracking, is caused by fatigue of the asphalt surface due to the repeated loading of the traffic. Typically, the cracking begins at the base of the asphalt surface and works its way up to the surface. Map cracking starts as a series of parallel, longitudinal cracking on the surface and progresses into map cracking as the parallel cracks begin to connect. Map cracking can later turn into potholes due to the underlying base issues that initially cause the map cracking to occur.

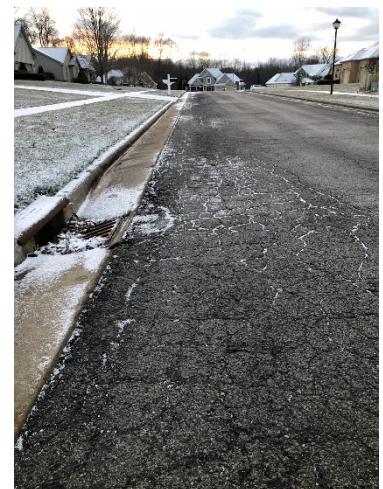
### 2.3 BASE FAILURE

Base failure occurs due to lateral movement in the pavements subgrade. A variety of issues could cause this including insufficient pavement thickness, inefficient asphalt compaction, or the infiltration of moisture. Typically, the repair for this is a full depth repair. For the purposes of this study, rutting was identified as a form of base failure.

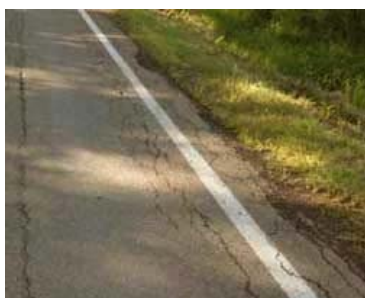
## 2.5 WHEEL TRACK AND EDGE CRACKING

Wheel track and edge cracking is cracking that occurs on the edge of the asphalt or within the typical wheel tracks. These types of cracks usually run parallel to the outer edge of the pavement and cracking is increased by continuous traffic loading. Edge cracking can be caused by weakened base or subgrade near the edge of the pavement. This type of cracking can lead to raveling, which means that the edge has broken off from the main asphalt road.
